DEPARTMENT OF TRANSPORTATION

Quality Assurance and Source Inspection

Contract #: 04-0120F4Cty: SF/ALA Rte: 80 PM: 13.2/13.9File #: 69.28**WELDING INSPECTION REPORT****Resident Engineer:**Siegenthaler, Peter**Address:** 333 Burma Road**City:** Oakland, CA 94607**Report No:** WIR-023491**Date Inspected:** 07-May-2011**Project Name:** SAS Superstructure**OSM Arrival Time:** 700**Prime Contractor:** American Bridge/Fluor Enterprises, a JV**OSM Departure Time:** 1900**Contractor:** Zhenhua Port Machinery Company, Ltd (ZPMC), Changxing Island **Location:** Shanghai, China**CWI Name:** An Qing Xiang**CWI Present:** Yes No**Inspected CWI report:** Yes No N/A**Rod Oven in Use:** Yes No N/A**Electrode to specification:** Yes No N/A**Weld Procedures Followed:** Yes No N/A**Qualified Welders:** Yes No N/A**Verified Joint Fit-up:** Yes No N/A**Approved Drawings:** Yes No N/A**Approved WPS:** Yes No N/A**Delayed / Cancelled:** Yes No N/A**Bridge No:** 34-0006**Component:** OBG**Summary of Items Observed:**

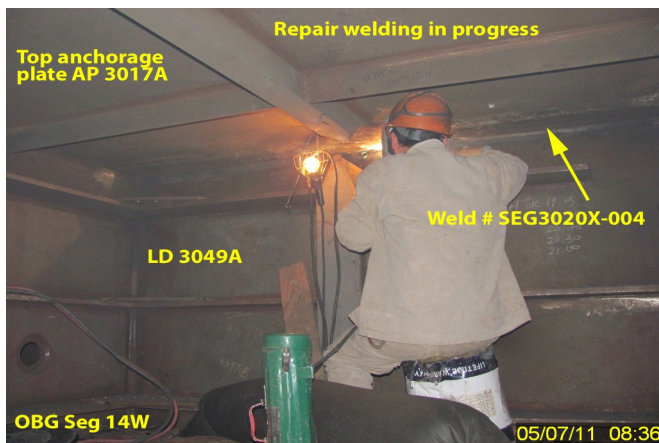
Repair welding of weld joint no: SEG3020X-004 [Top AP 3017A to Longitudinal Diaphragm (LD) 3049A, CJP weld in between PP 125 to PP125.5]. The welder is identified as 045246 and was observed welding in the 4G position. Welding process was identified as SMAW. ZPMC QC was identified as Mr. An Qing Xiang. The welding variables recorded by this QC appeared to comply with WPS: 345-SMAW-4G(4F)-FCM-Repair-1. Repair welding was done as per Welding Repair Report (WRR): B-WR 20845 Rev-0. See attached photograph for further details.
